PRELIMINARY ENGINEERING REPORT

RESERVOIR NO. 2 AND NONPOTABLE WATER TRANSMISSION LINE EVALUATION

TOWN OF ORDWAY

PROJECT NO. 14059.150

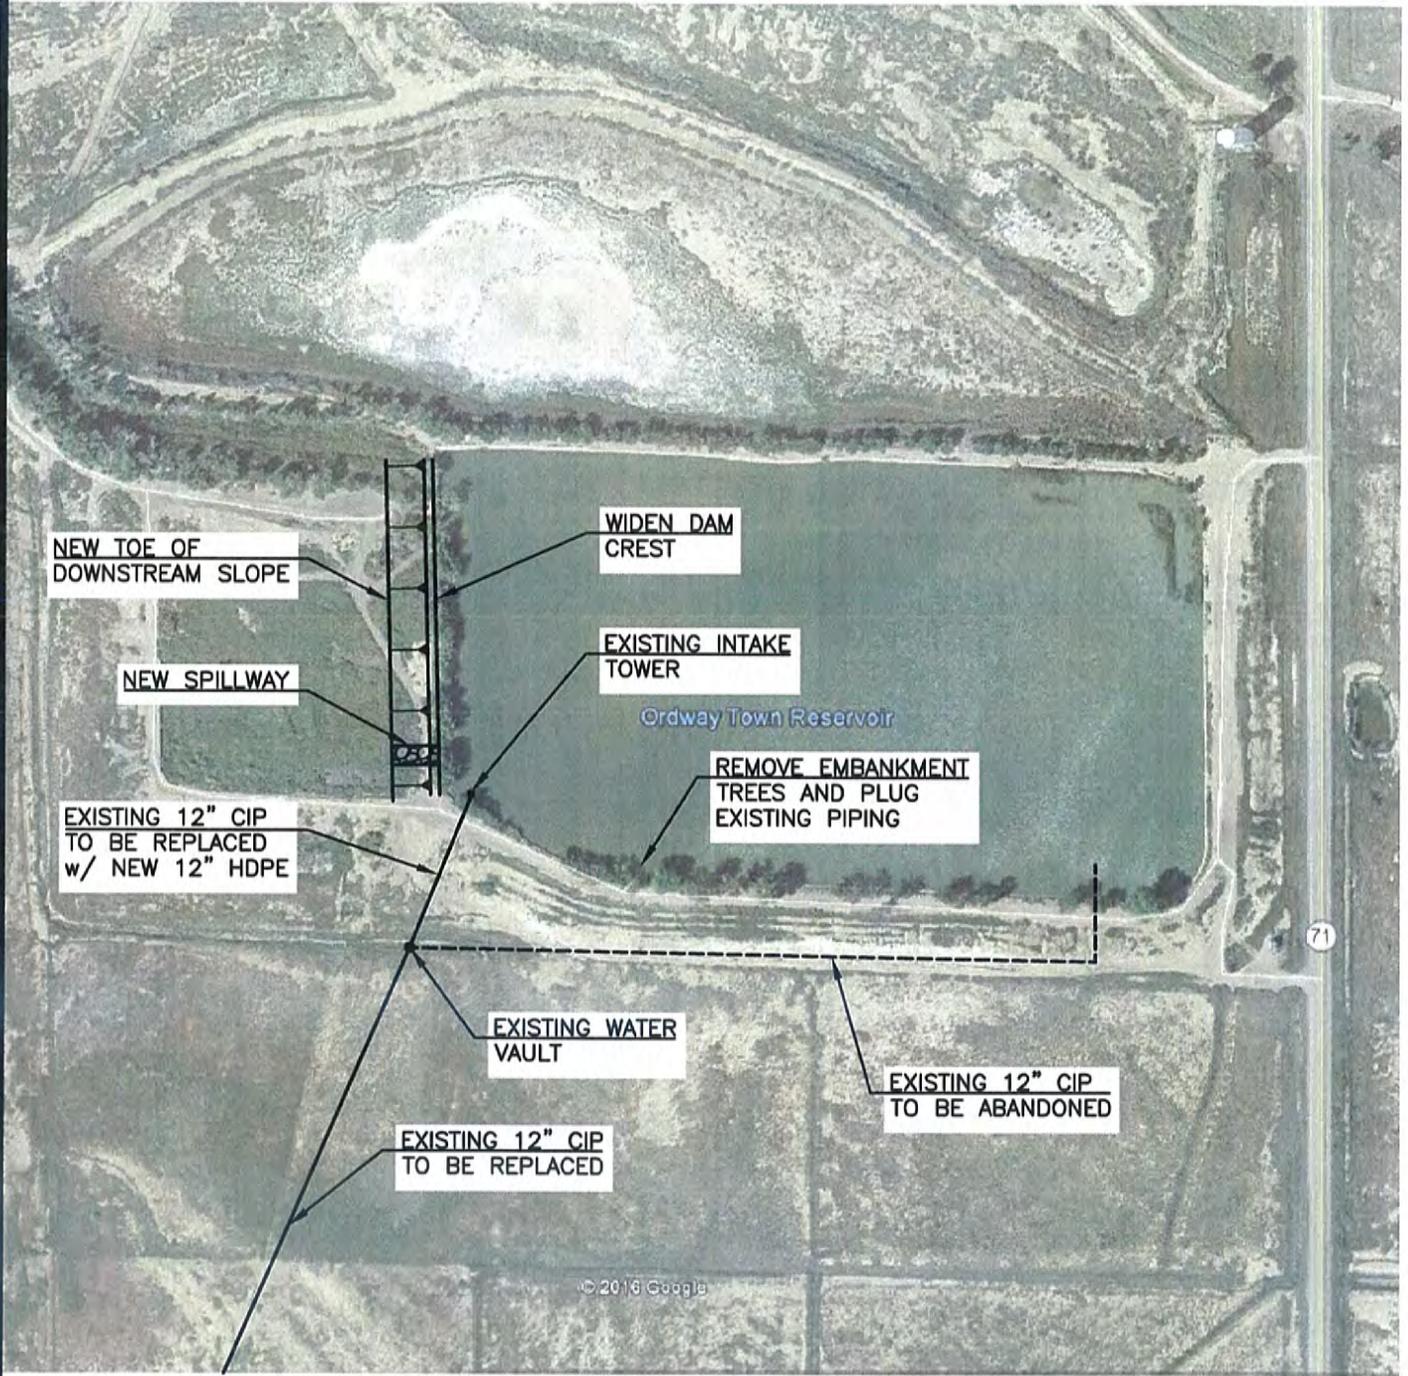
through the embankment is found to be in serviceable condition. See Figure 4 for the recommended Ordway Dam Improvements.

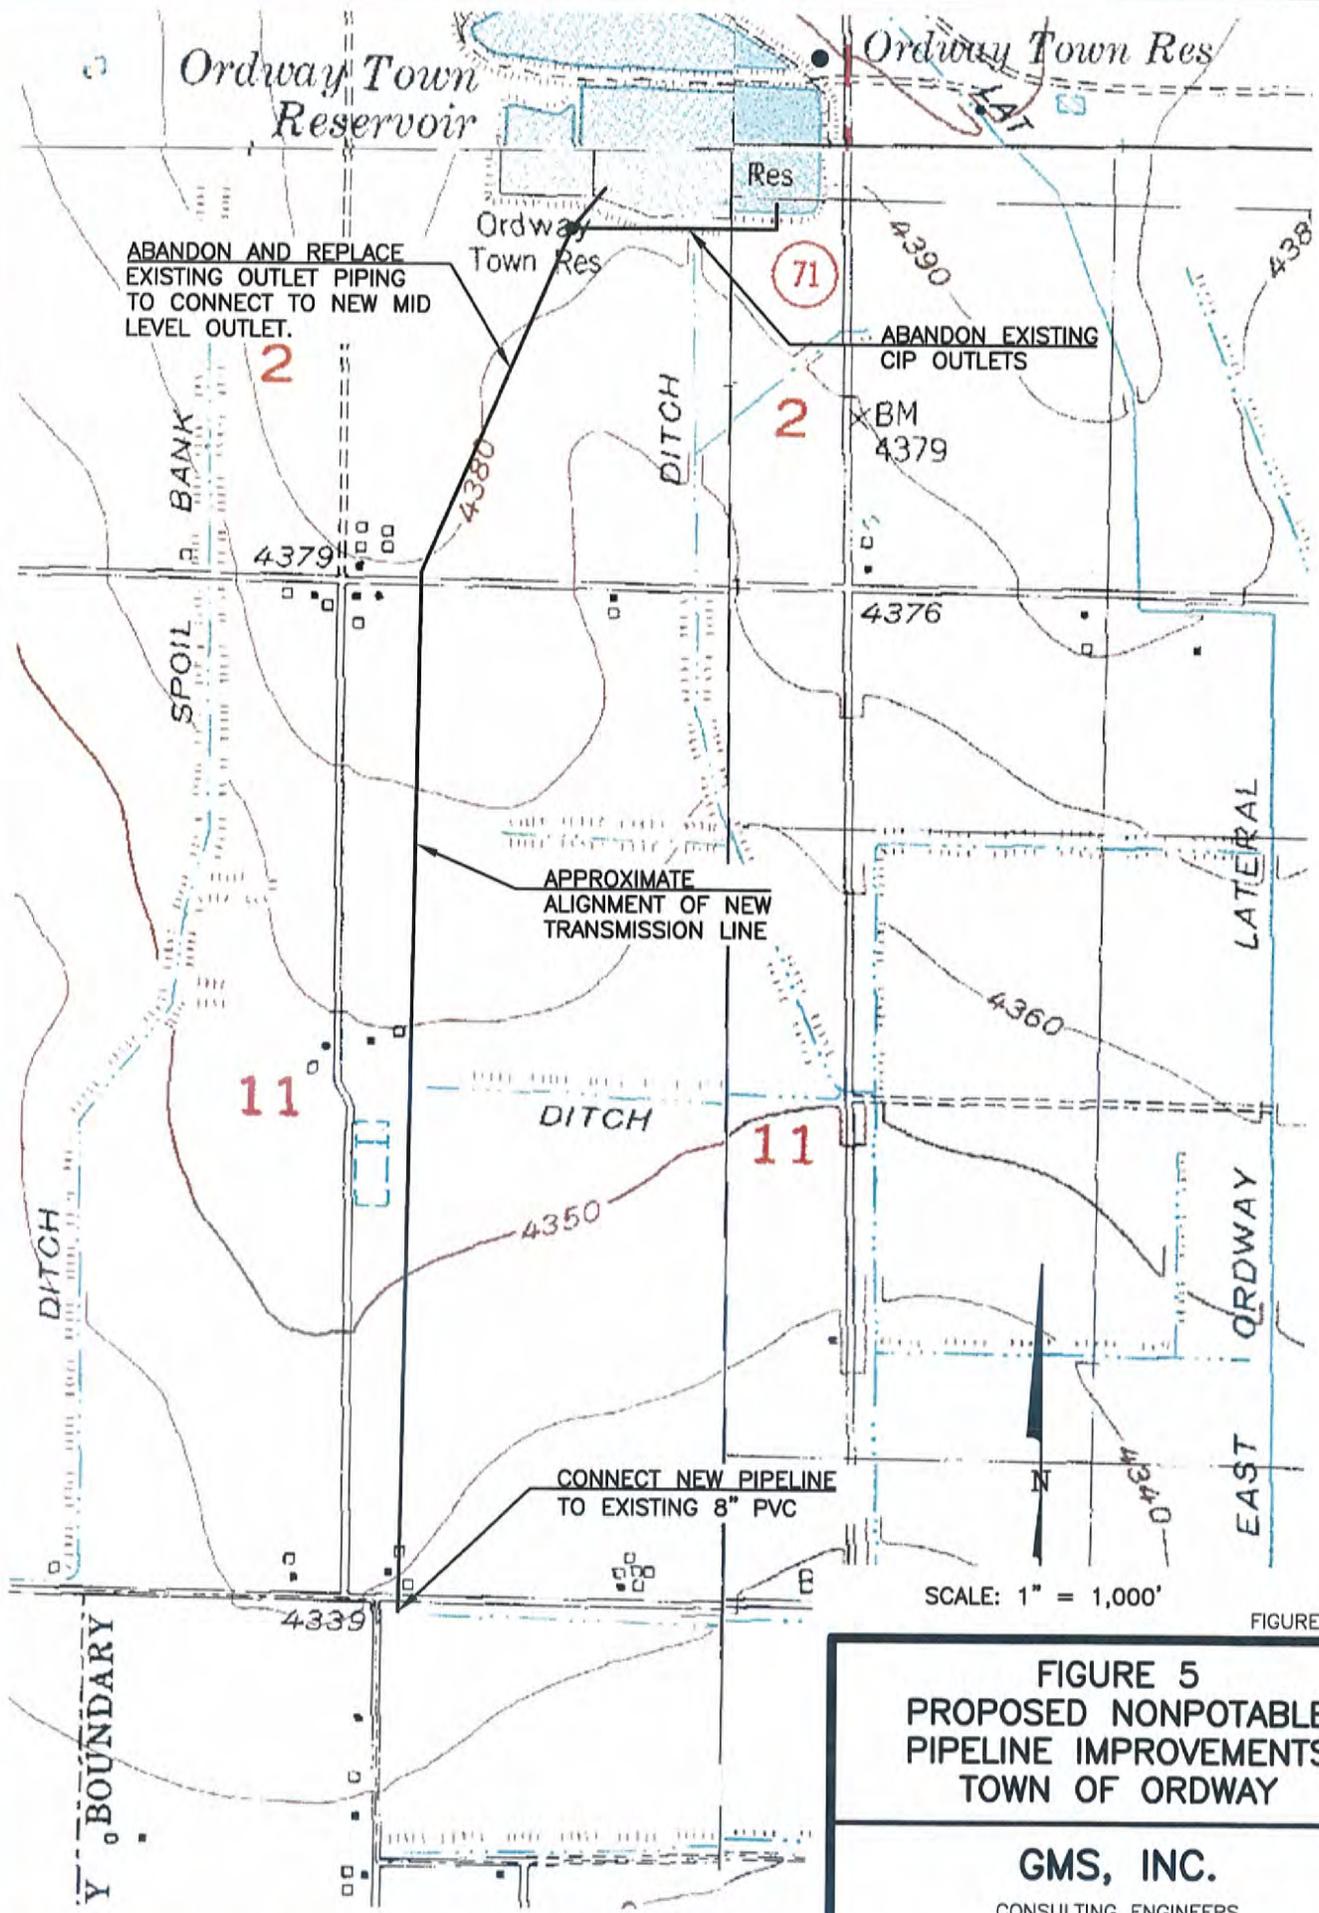
FIGURE 5.DWG

- The 12" cast iron piping extending from the reservoir to County Road H has deteriorated where observed and has experienced several breaks. The pipeline from the water vault to the connection with the 8" PVC irrigation pipeline at County Road H could be abandoned and replaced with a new 6-inch PVC pipeline constructed in a separate trench, or with a 6-inch HDPE pipe slipped into the existing 12-inch CI pipe. The existing 12-inch piping between the outlet tower and water vault can remain in service, but needs to be drainable when not providing irrigation water to the Town. Diversions into the nonpotable pipeline will be provided with upgradient control with the outlet tower modifications previously discussed. See Figure 5 for the general alignment of the new nonpotable transmission pipeline between the reservoir and County Road H.

Based on the limited use of the nonpotable water system to irrigate just the Town Park and school's athletic fields, the approach of sleeving a new 6-inch HDPE pipe in the existing 12-inch CI pipe is recommended to replace the existing transmission pipeline between the existing water vault and County Road H. The costs associated with irrigating the Town Park and the school's athletic fields with water from the potable water system is significant. Therefore, replacement of this transmission is recommended.

The replacement of the existing 12-inch pipeline with a new fused 6-inch HDPE pipe is considered to be the most cost effective. Potential environmental impacts resulting from water system improvements with a slipline replacement are greatly reduced.
