PRELIMINARY ENGINEERING REPORT

RESERVOIR NO. 2 AND NONPOTABLE WATER TRANSMISSION LINE EVALUATION

TOWN OF ORDWAY

PROJECT NO. 14059.150

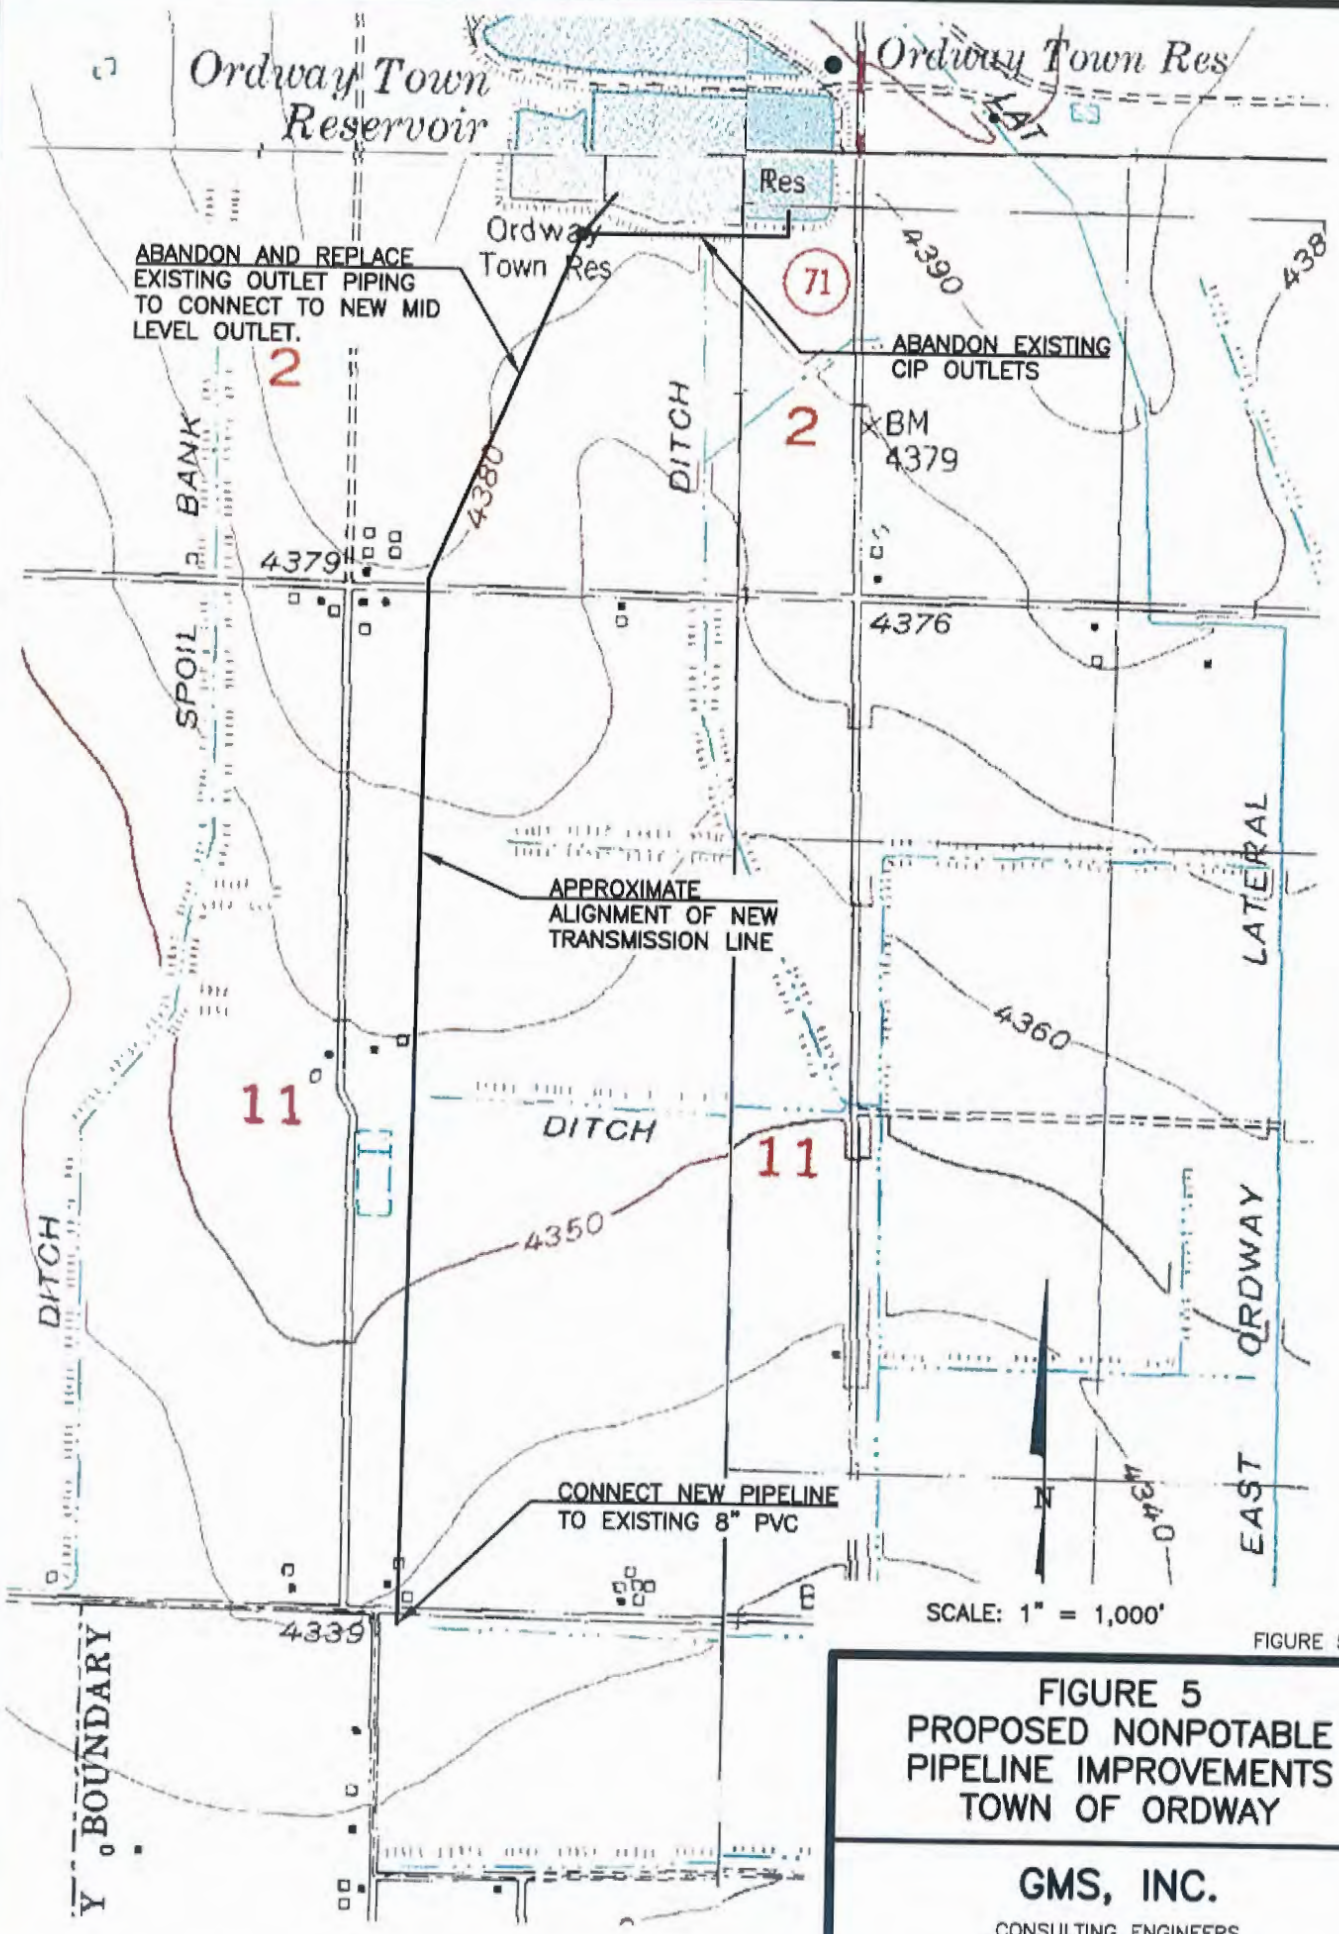
FIGURE 5.DWG

- The 12" cast iron piping extending from the reservoir to County Road H has deteriorated where observed and has experienced several breaks. The pipeline from the water vault to the connection with the 8" PVC irrigation pipeline at County Road H could be abandoned and replaced with a new 6-inch PVC pipeline constructed in a separate trench, or with a 6-inch HDPE pipe slipped into the existing 12-inch CI pipe. The existing 12-inch piping between the outlet tower and water vault can remain in service, but needs to be drainable when not providing irrigation water to the Town. Diversions into the nonpotable pipeline will be provided with upgradient control with the outlet tower modifications previously discussed. See Figure 5 for the general alignment of the new nonpotable transmission pipeline between the reservoir and County Road H.

Based on the limited use of the nonpotable water system to irrigate just the Town Park and school's athletic fields, the approach of sleeving a new 6-inch HDPE pipe in the existing 12-inch CI pipe is recommended to replace the existing transmission pipeline between the existing water vault and County Road H. The costs associated with irrigating the Town Park and the school's athletic fields with water from the potable water system is significant. Therefore, replacement of this transmission is recommended.

The replacement of the existing 12-inch pipeline with a new fused 6-inch HDPE pipe is considered to be the most cost effective. Potential environmental impacts resulting from water system improvements with a slipline replacement are greatly reduced.

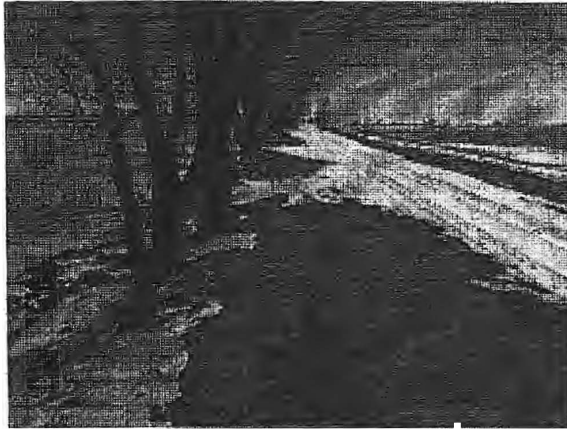
Photo 1- Dam crest and trees on upstream shoulder, looking left across the south dam of Ordway Town Res. Cell No. 2.

All trees growing on the dam embankment will require complete removal, including the root systems. The tree roots can deteriorate over time and provide a conduit for water to readily flow through the embankment. Some tree removal was conducted by the Town in 2015, but was limited by the size of the Town's equipment. Using a 2019 image from Google Earth, approximately 90 trees remain to be removed from the west, south and east embankments. Trees on the north side of the north embankment were not considered for removal. The voids created during the removal activity must be filled with properly compacted soil.

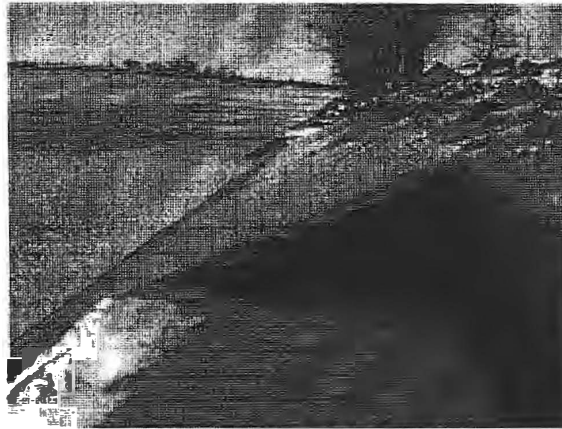
The entire perimeter of Reservoir No. 2 is lined with concrete slab slope protection. Most all of this slope protection has been compromised. Voids are visible behind slabs and several slabs have collapsed. Concrete paving for slope protection has a high occurrence of failure according to a survey conducted by the U.S. Army Corps of Engineers. The U.S. Bureau of Reclamation favors the use of dumped riprap slope protection as being the most effective.

Photo 2 – Upstream slope with typical collapsed concrete slab facing (foreground).

The short-term solution for embankment protection, as recommended by the DSB, comes at a lower cost. However, frequent inspection and maintenance/repair will be required by the Town. For voids under concrete slabs of less than three feet, the void needs to be filled with concrete. This can be a low strength flowable fill or a pressure grout. For voids under concrete slabs of greater than three feet, or slabs that have collapsed or have broken up, the concrete needs to be removed and replaced with compacted select backfill, gravel bedding and riprap. The extent and scope of the concrete slab slope protection has not been established. A detailed inventory of all slabs around the reservoir needs to be conducted to establish final cost estimates for this repair activity. For the purpose of this report, the cost estimate is based on this short-term repair approach. The cost estimate uses 20% of the south, east, and west embankments to have concrete slab removal and replacement with bedding and riprap. The remaining 80% of the slope protection is assumed to require, on average, 4 cubic feet of flow fill or pressure grout injected under each individual slab. The north embankment is considered low-risk. No improvements to the north embankment are recommended with these short-term improvements.

For short term repair/stabilization of the concrete facing, we recommend performing a detailed inventory of the voids & condition behind the concrete facing. Determine how deep voids are: if less than 3-ft, we recommend filling voids with concrete or removing the slab and replacing with gravel bedding and riprap. If more than 3-ft deep, contact an engineer experienced in the design and construction of dams to assist with rehab.

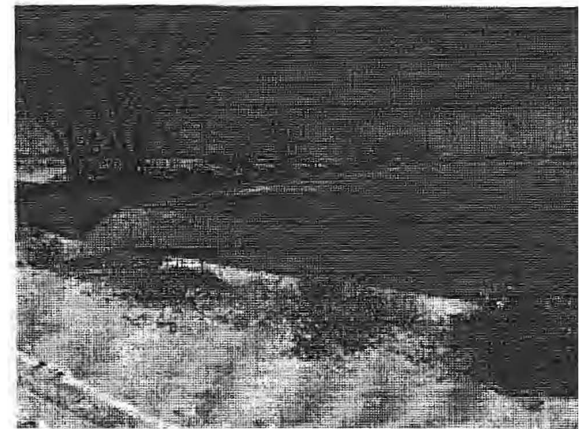
Photo 3 – View of the reservoir and upstream slope of the south dam, looking right from the east dam.

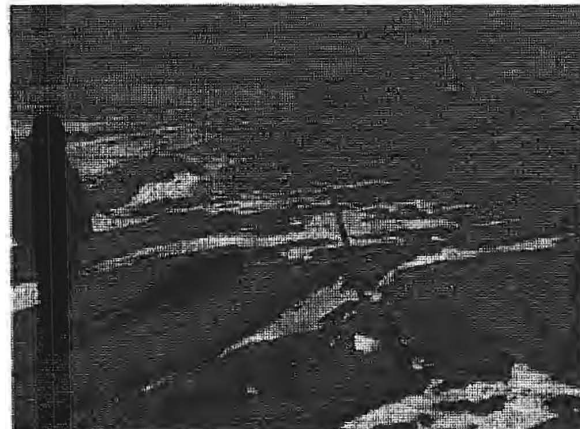
Photo 4 – Downstream slope of the south dam, looking right from the SE corner of the facility. Valve box in the foreground (red arrow) is reportedly for one of two 12” CIP outlet pipelines (other is near the SW corner).

Due to the deteriorated condition, location, and age of the existing outlet pipes, reportedly two (2) 12-inch CIP, the recommendation is made that the east outlet pipe be grouted full and abandoned where it extends through the dam embankment. Modifications will valve off reservoir discharges on the upstream side of the embankment, eliminating a pressurized pipe under the embankment. This will also allow for camera inspections of the outlet pipe under the embankment.

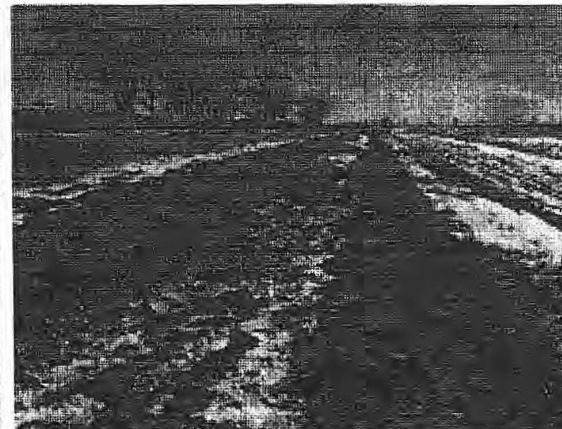
Photo 5 – Downstream slope of the south dam looking left (east). Slope is terraced.

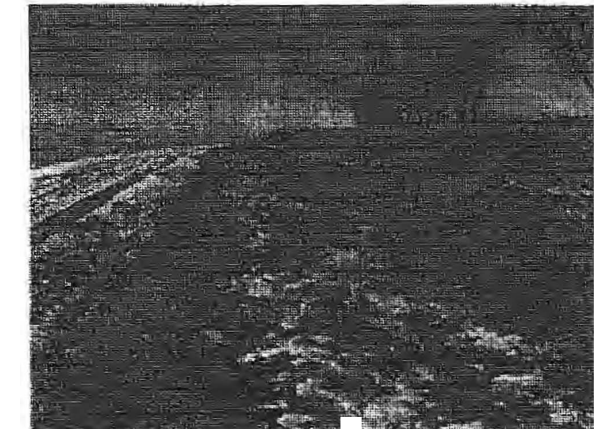
Photo 6 – Downstream slope of south dam looking right near SW corner of the facility.

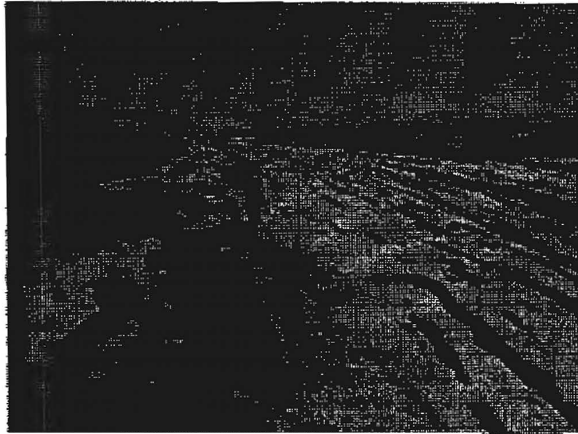
Wet and rutted soils were observed at the southwest corner of the south embankment toe. The 2014 inspection dug multiple holes in this area and found firm, dry soil at approximately 6-inches deep. The wet soils in this area are due to poor drainage. The DSB suggested approximately 300 feet of the downstream toe in this area receive fill to promote surface drainage away from the dam. The repaired area should be monitored to determine if wet conditions reappear which would indicate potential seepage in this area. Acceptable soil should be used for this fill activity.

Photo 7- Rutted area along the downstream toe of the south dam near the SW corner of the facility. Potholes with shovel revealed that soil below the top 6 inches was dry and firm.

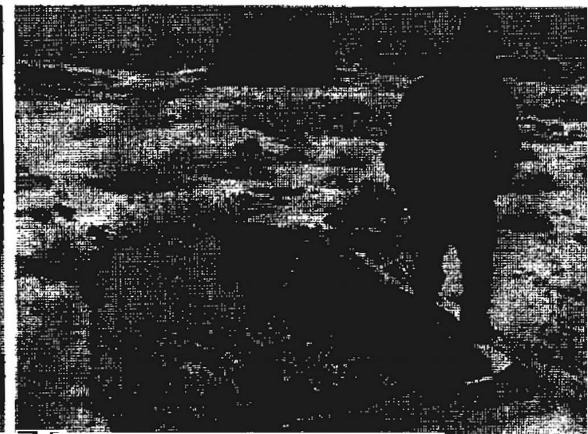
Photo 9 - Concrete vault located several hundred feet downstream of the dam at SW corner. Reportedly both 12" CIP pipelines join here and pipeline continues to Town.

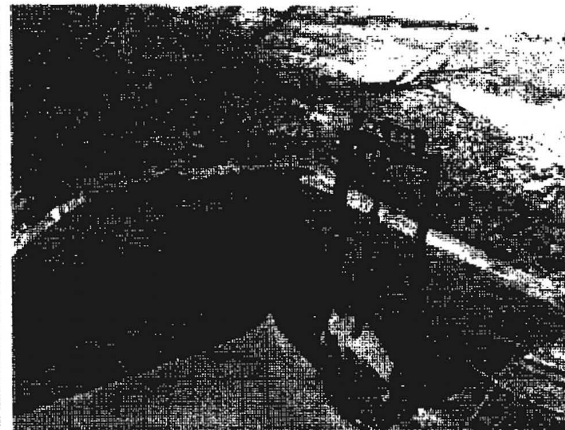
Photo 11 - Connector pipe between Cell 2 (photo left) and Cell 3 (photo right).

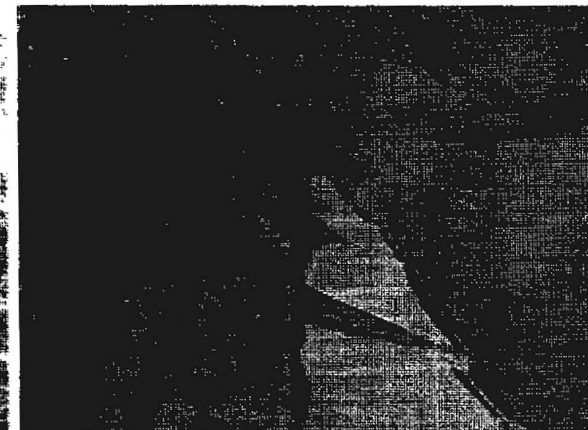
Photo 12 - Concrete slab facing on the upstream slope of the west dam (interior dike between Cells 2 & 3). Note overgrown trees on west dam (photo left).
